TECHNICAL EVALUATION

Life/Performance Expectancy of Rubber Gaskets: Analysis of Water Transmission Gasket Installed in 1962

Synopsis: *A rubber gasket in service since 1962 is analyzed and a service life in excess of 100 years is projected.*

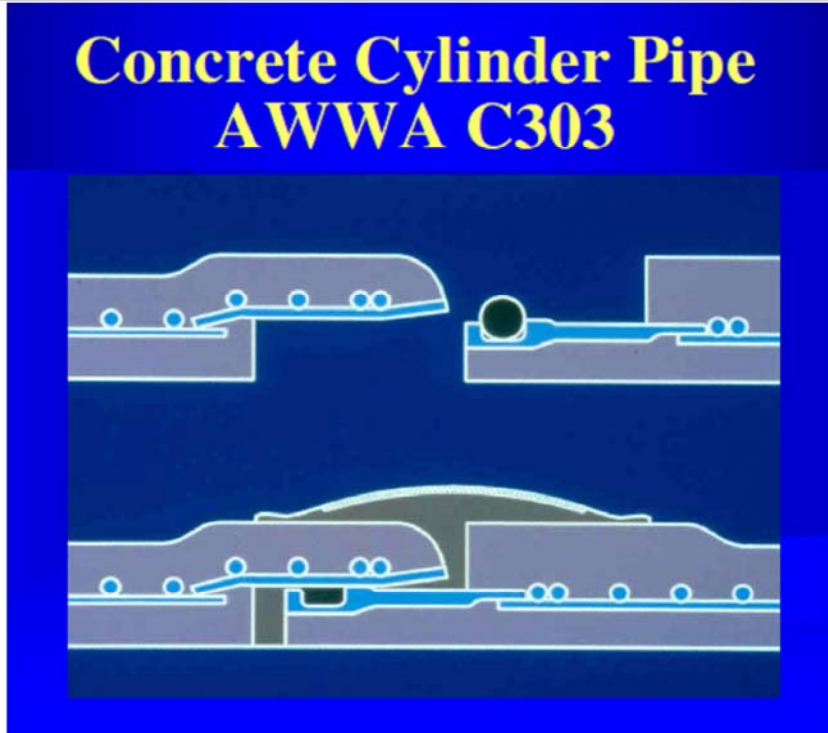
Schematic representation of sample gasket in assembled joint

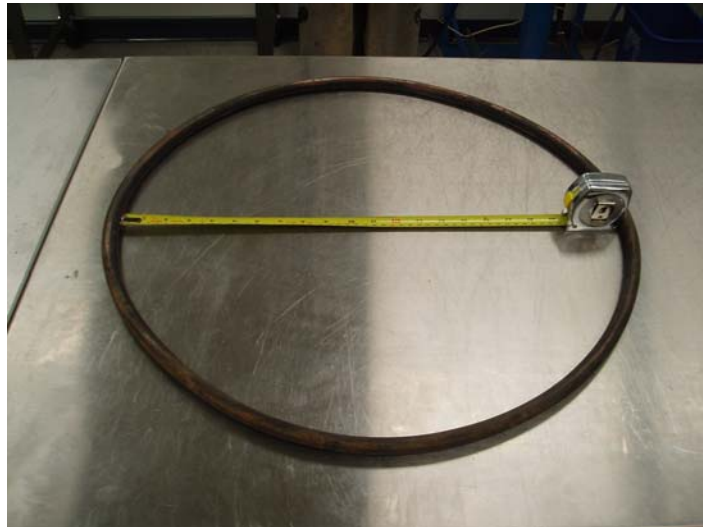
The gasket was measured and the following was found:

Length	71.375 inches (1813 mm)
Weight	0.913 lbs. (415 grams)
Diameter	~0.690 ~ 0.560 inches (~0.130 inch ovality)
	~17.56 ~ 14.22 mm (~3.34 mm ovality)
Volume	373 cc

Gasket laid out for measurement

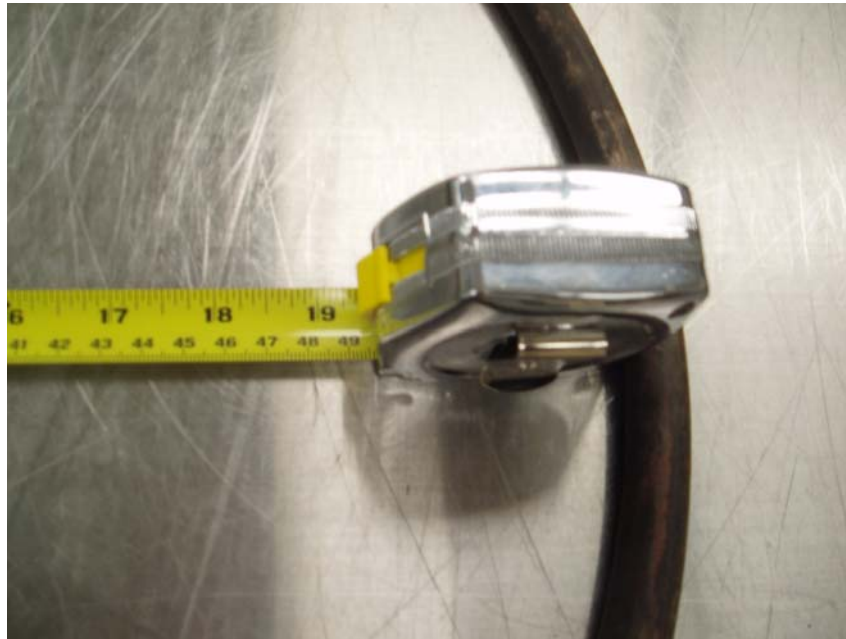
Inside measurement of gasket

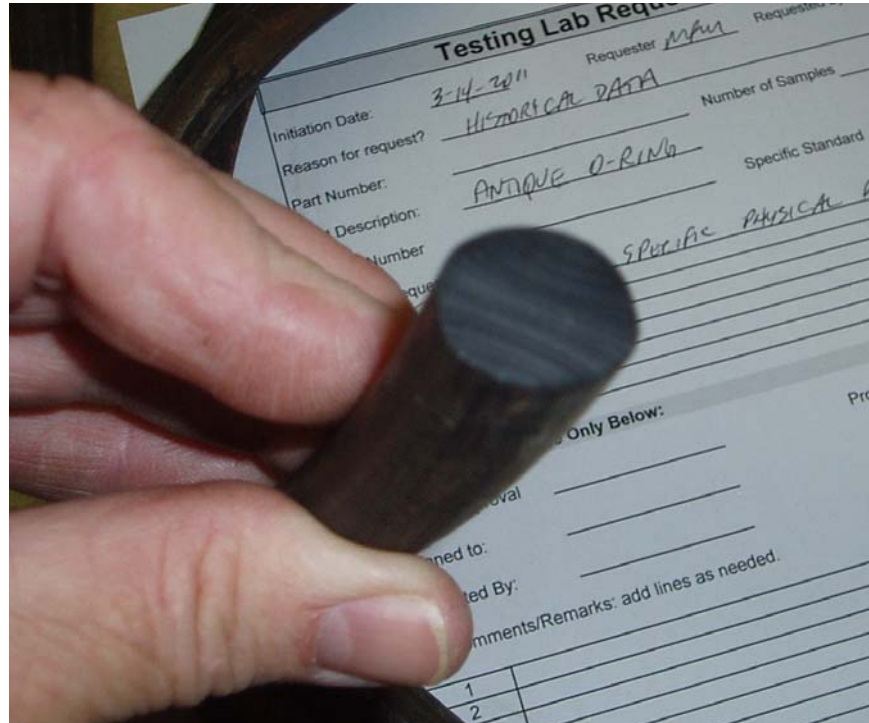
1. The sample gasket demonstrates the effect of prolonged elongation in that it has assumed a profile of extended length with a reduced cross-section, despite the fact that the rubber demonstrates very low tension set properties, which is the tendency of a stretched gasket to become longer as a result of being stretched continuously.
2. The gasket shows compression ovality typical of a high-compression joint seal, such as that used in steel cylinder pipe.

Gasket end showing ovality

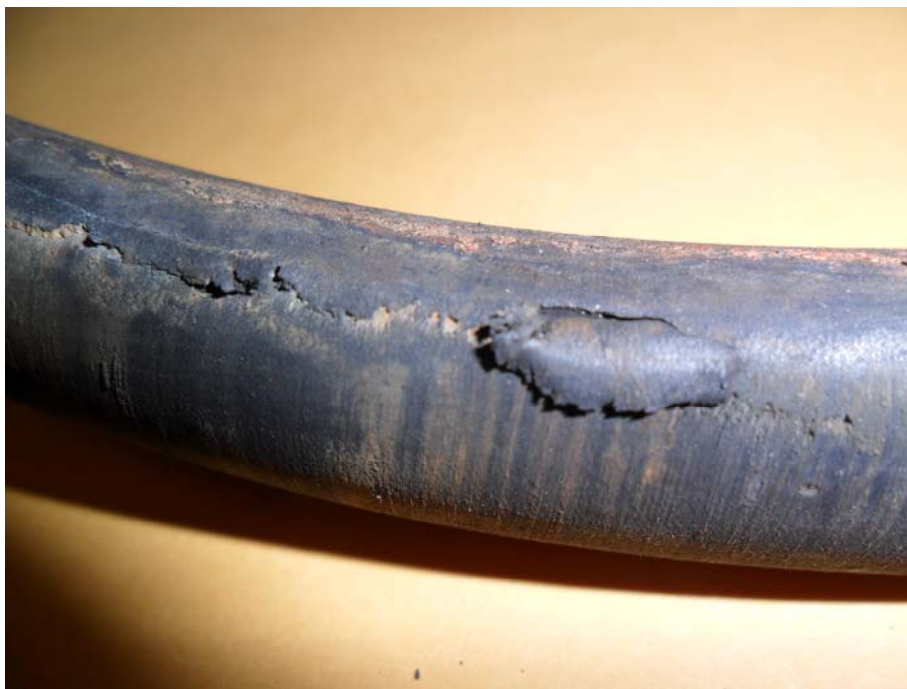
The gasket was a molded product, as there was no detectable splice and there was a small parting line (area where molds halves join) around the diameter of the part. There were several areas of abrasion, including areas where the rubber surface had slight tears. This is likely due to the disassembly process, where the gasket would have adhered to the steel joint rings over the course of the years.

Gasket showing abrasive separation
